On 21/7/2022 the undersigned Stefano Pisano

MODEL : GRAND BANKS 52 EUROPA NAME : ██████████
██████████

BUILDER : GRAND BANKS

Pre purchase survey

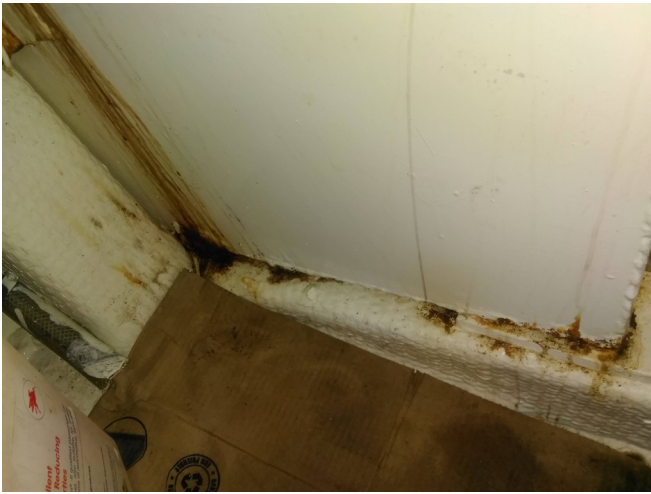
Diesel tanks made by steel over painted, shows rust especially at the edges of the left one. Both ***must be investigated thoroughly***- serviced and fixed or changed.

Figura 2: left tank rusty

- the right stabilizer with leaks and swing - new bush
- diesel leaks on the handles of Racor of engines- fix
- diesel tanks with rust especially the left one - fix or change

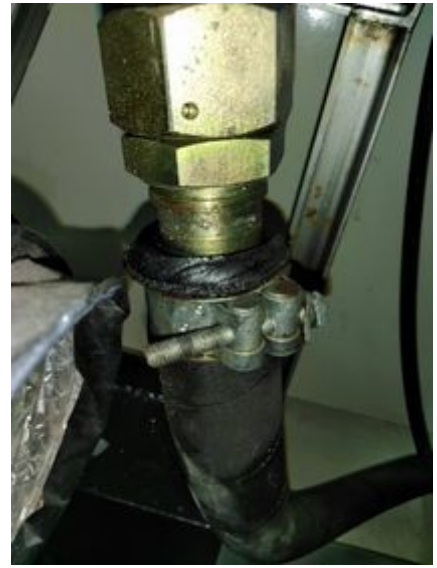
Figura 1: hydraulic bad mounted

- black hose (approx 35 mm diameter) from hydraulic oil tank - to tighten
- some cosmetics gelcoats defects on the walls (bottazzo)
- some cosmetics defects on dinghy crane

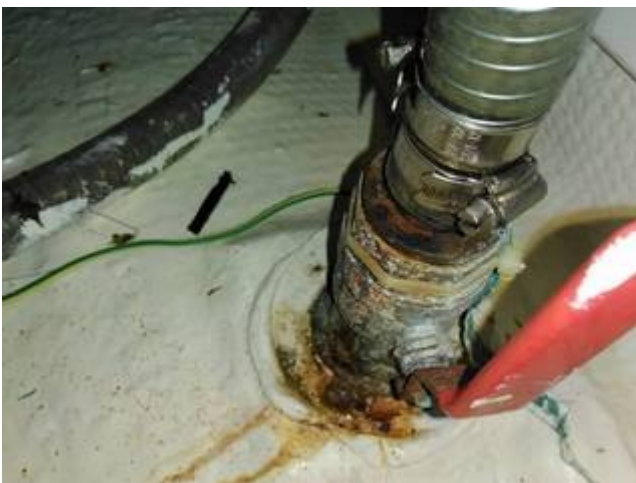
It is recommended to change the seacock of generator and to pay attention to the ones of air condition system (3 seacocks). These are made of brass

Figura 4: generator seacock

- seacocks for A/C systems not in bronze - to keep under control
- seacock of generator not in bronze with leaks - to be changed
- all others seacocks bronze locked - to be serviced

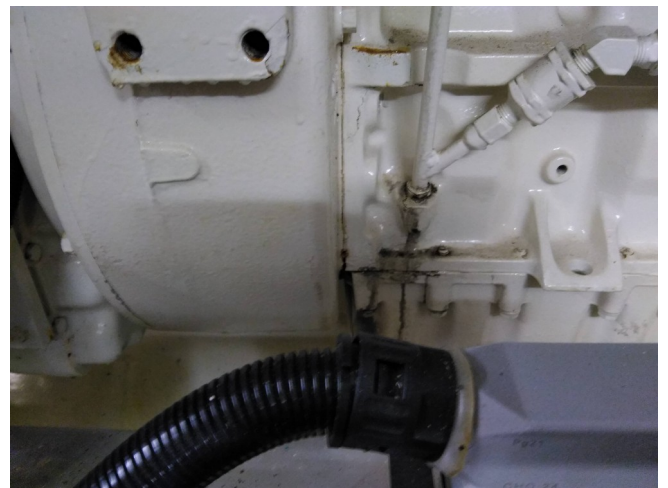
Externally, the engines appear with no sign of damage, and few leaks of oil mostly reported on the left engine;

The engines are in good condition, while in the left engine there is a slight oil leakage in the rear part between the oil sump and crankcase at flywheel height (work to be verified during repair process).

Figura 3: left engine leak

We recommend a complete engine seasonal service and a checkthe of the oil leakage in the right engine.

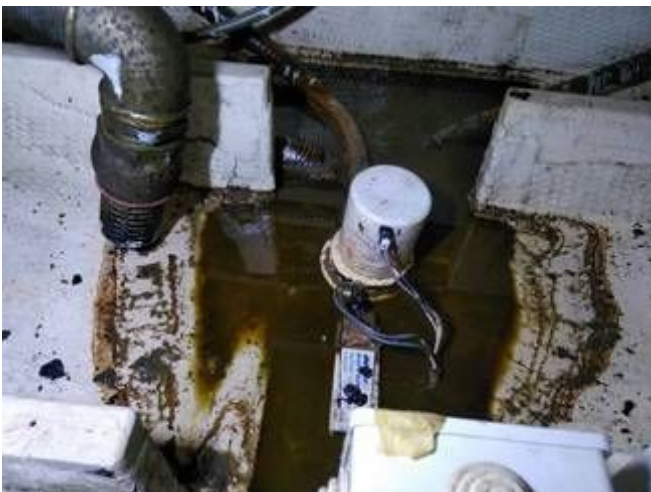
In the central bilges areas was found salt water while in the engine room bilges were found water, hydraulic oil and few diesel liquids.

Central bilge between engines shows hydrocarbons and water -5 lt approx
The systems appear to be in good condition, as are the sleeves and pipes, which are soft and not crystallised.

Figura 5: engine room bilge

- A/C cooling grid deteriorated - change
- water in bilge with oil - to clean and check
- both stabilizer rudders with oil leak from pistons - to be serviced

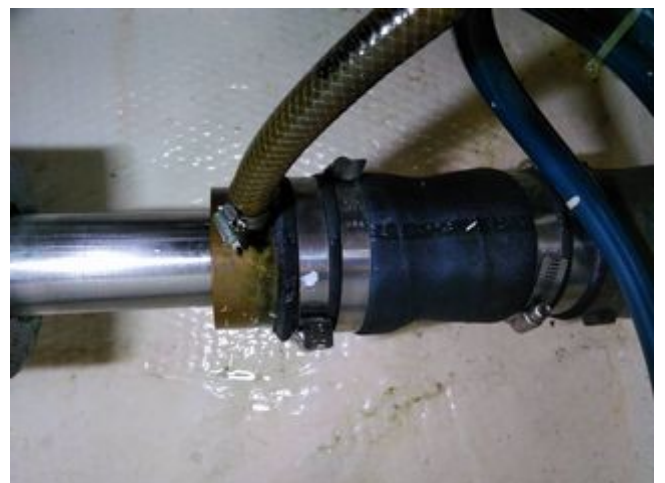
The right rubber of the shaft suffers a leaks from Racor filter mounted above it.

Figura 6: gasoline leak over rubber
